RESEARCH ON DEFORMATIONS WHICH APPEAR IN WITHIN THE METAL STRUCTURES OF MINING EQUIPMENT

Analyzed metallic construction “excavator arm ERC 1300” is obtained from the highlights of rolled St 52.3 steel with thickness of 10 / mm, positioned and assembled by manual welding with basic electrodes.

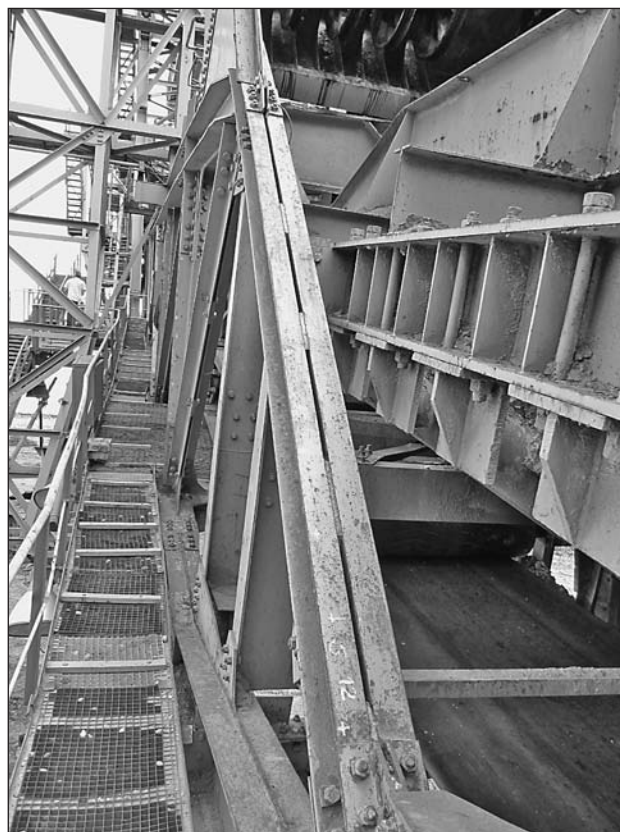
Figure 2 The deformed element of the excavator arm

intergranular corrosion phenomena and high mechanical requests. Thus in the first phase of experimental research it was visually analyzed the deformations area and were not found superficial corrosion areas where is currently a continuously coating layer Figure 2. Also, the method of deforming the excavator arm element is shown in Figure 3.

Due to the lack of a visible surface corrosion in the next step we aimed to determine possible corrosion phenomena that may occur under the paint and can affect the metal structure. To identify these corrosion phenomena it was used in the experiments LAPTOCOP

From the results shown in Table 2 it can be observed the fact that the thickness of the KL element is approximately 10,9 / mm, and this size is formed from a layer of paint and oxide plus the thickness of the metal part. After the measurements was found that in the area of points 9 ÷ 11 is the thickest layers of paint and oxides, and in this area there is the smallest thickness of the metal layer, namely the thickness is reduced by 5-6 / % in relation to the new state. In these conditions it was observed that in this area the maximum deformation which extend and has an increasing length.

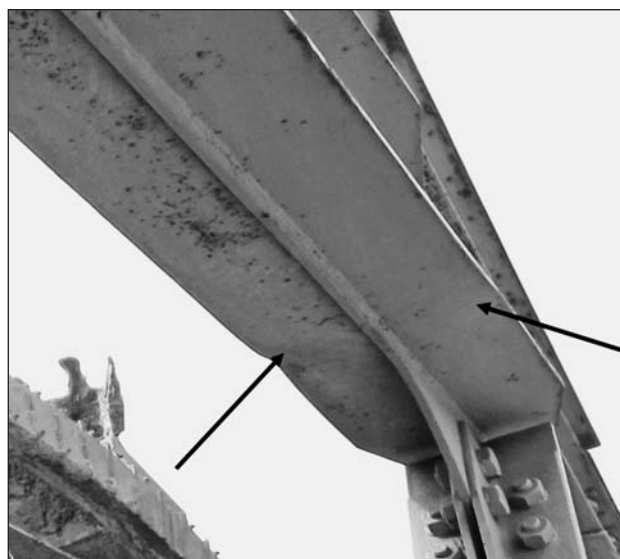
Figure 3 The mode of deformation of the excavator arm element
